Assessment of Vine Quality and Pruning Techniques in Oklahoma Vineyards

Eric T. Stafne^{1*} and Becky Carroll² ¹Coastal Research and Extension Center, Mississippi State University, Poplarville, MS 39470; ²Department of Horticulture and LA, Oklahoma State University, Stillwater, OK 74078

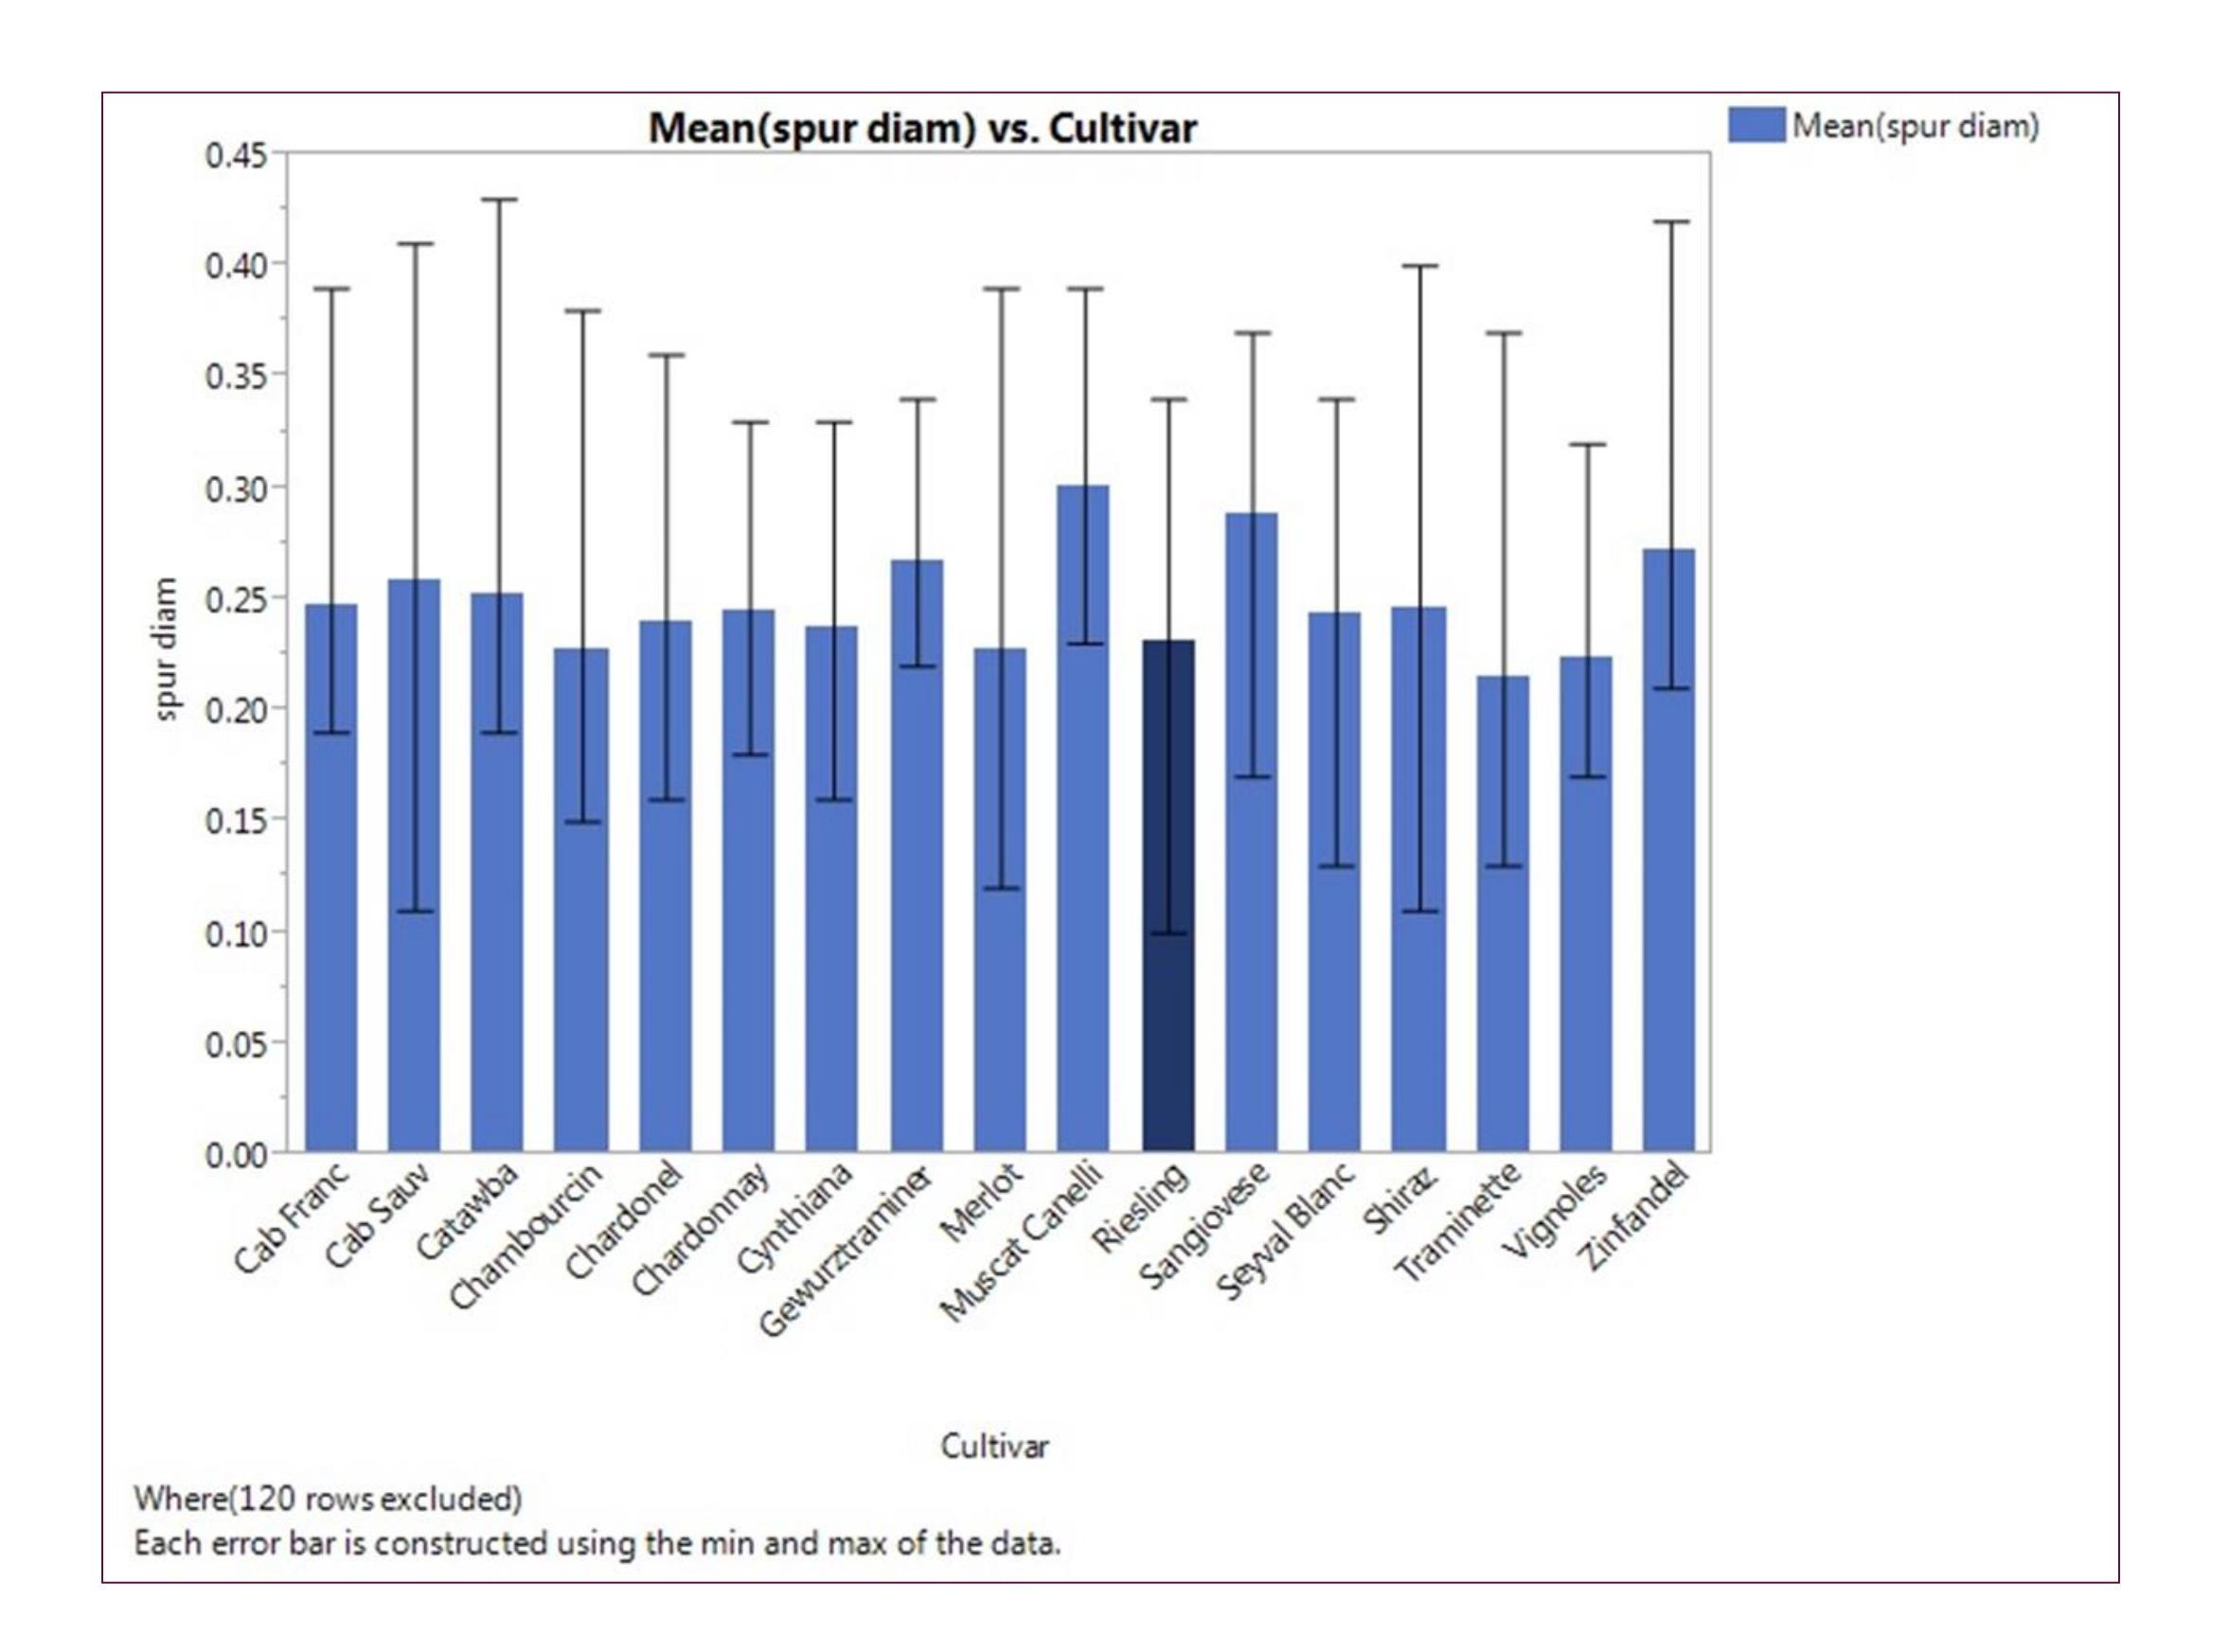
Data shows that among all cultivars observed, few spurs were within the desired range of 0.8 to 1.3 cm diameter (Fig. 3). This indicates potential problems such as poor vigor (possibly due to own-rooted vines), poor nutrition, lack of adequate water, poor weed management, too much crop load in previous year, or leaving too many shoot/canes the previous years. Less of a problem was spur internode length. Although within the broad parameters of 2.5 to 10 cm, most cultivars in Oklahoma fell in the lower part of that range (Fig. 4). The number of spurs per linear foot by cultivar was too many in most vineyards in Oklahoma. The desired range is ~2.5 spurs per linear foot of canopy; however, most observed were greater than 3 and most over 4 (Fig. 5).

Fig. 3. Mean spur diameter (cm) by cultivar over all locations from Oklahoma vineyards. Only cultivars planted in at least two vineyards were analyzed.

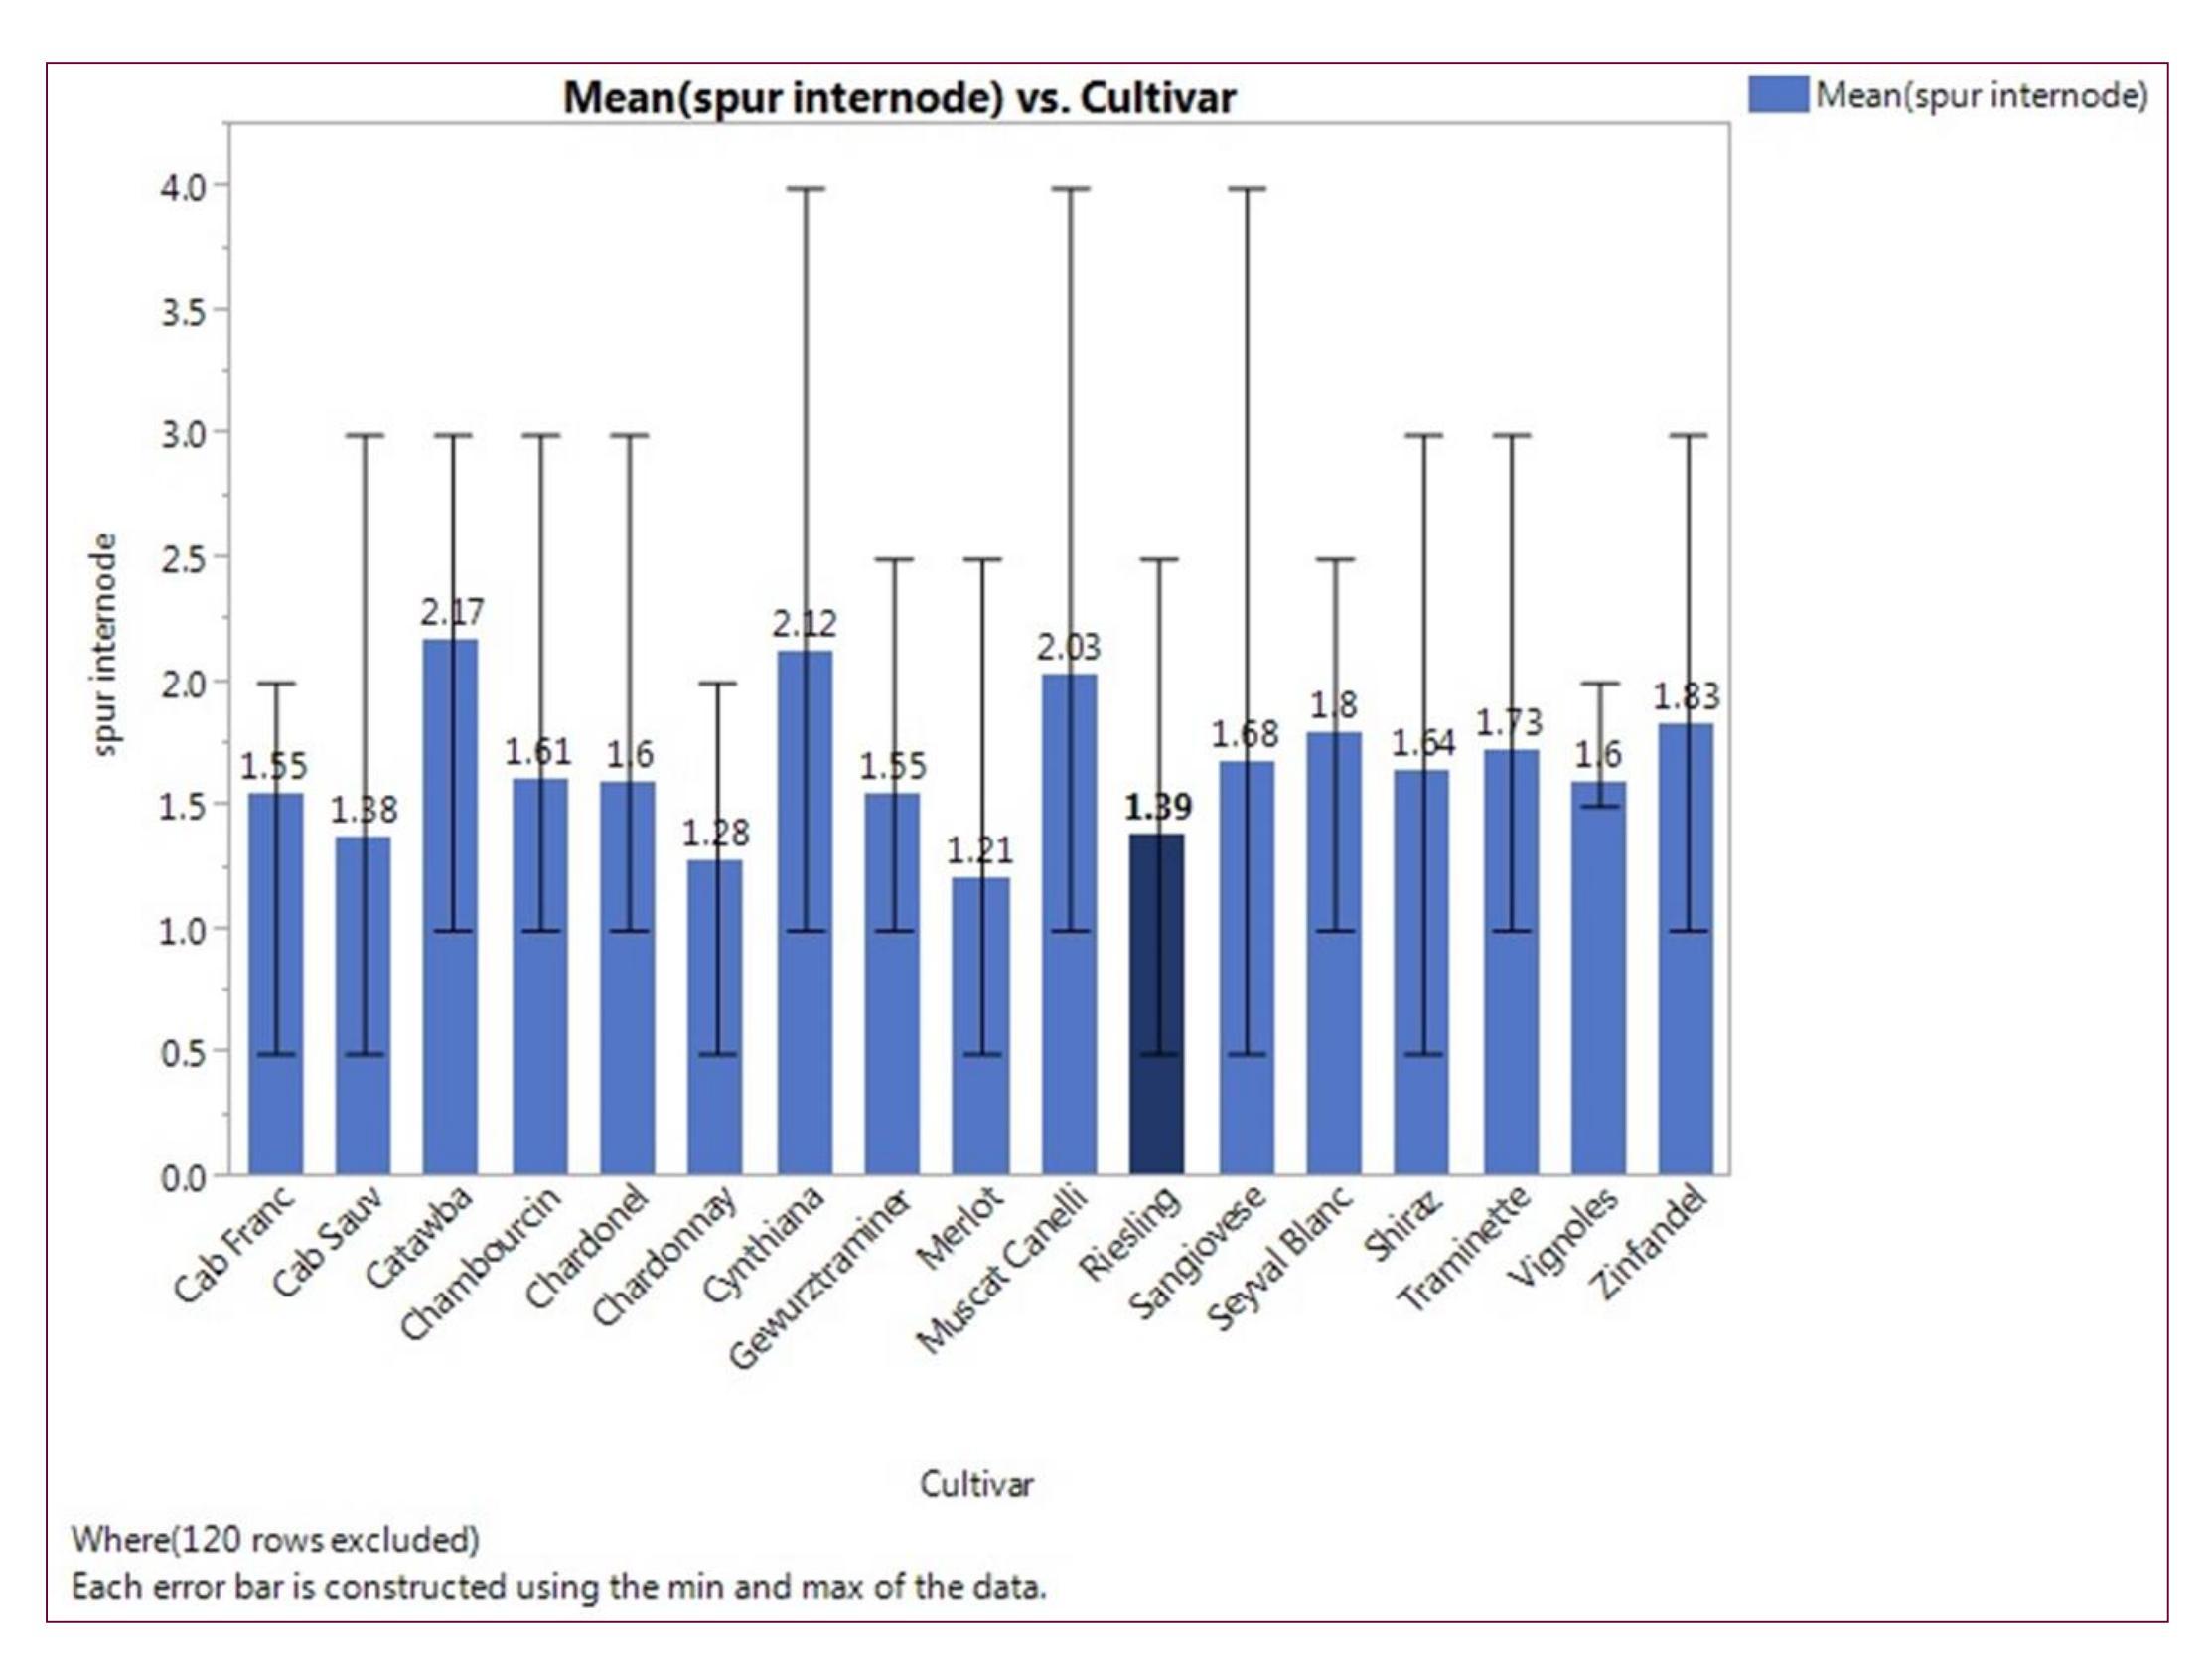
Fig. 4. Mean spur internode length (cm) by cultivar over all locations from Oklahoma vineyards. Only cultivars planted in at least two vineyards were analyzed.

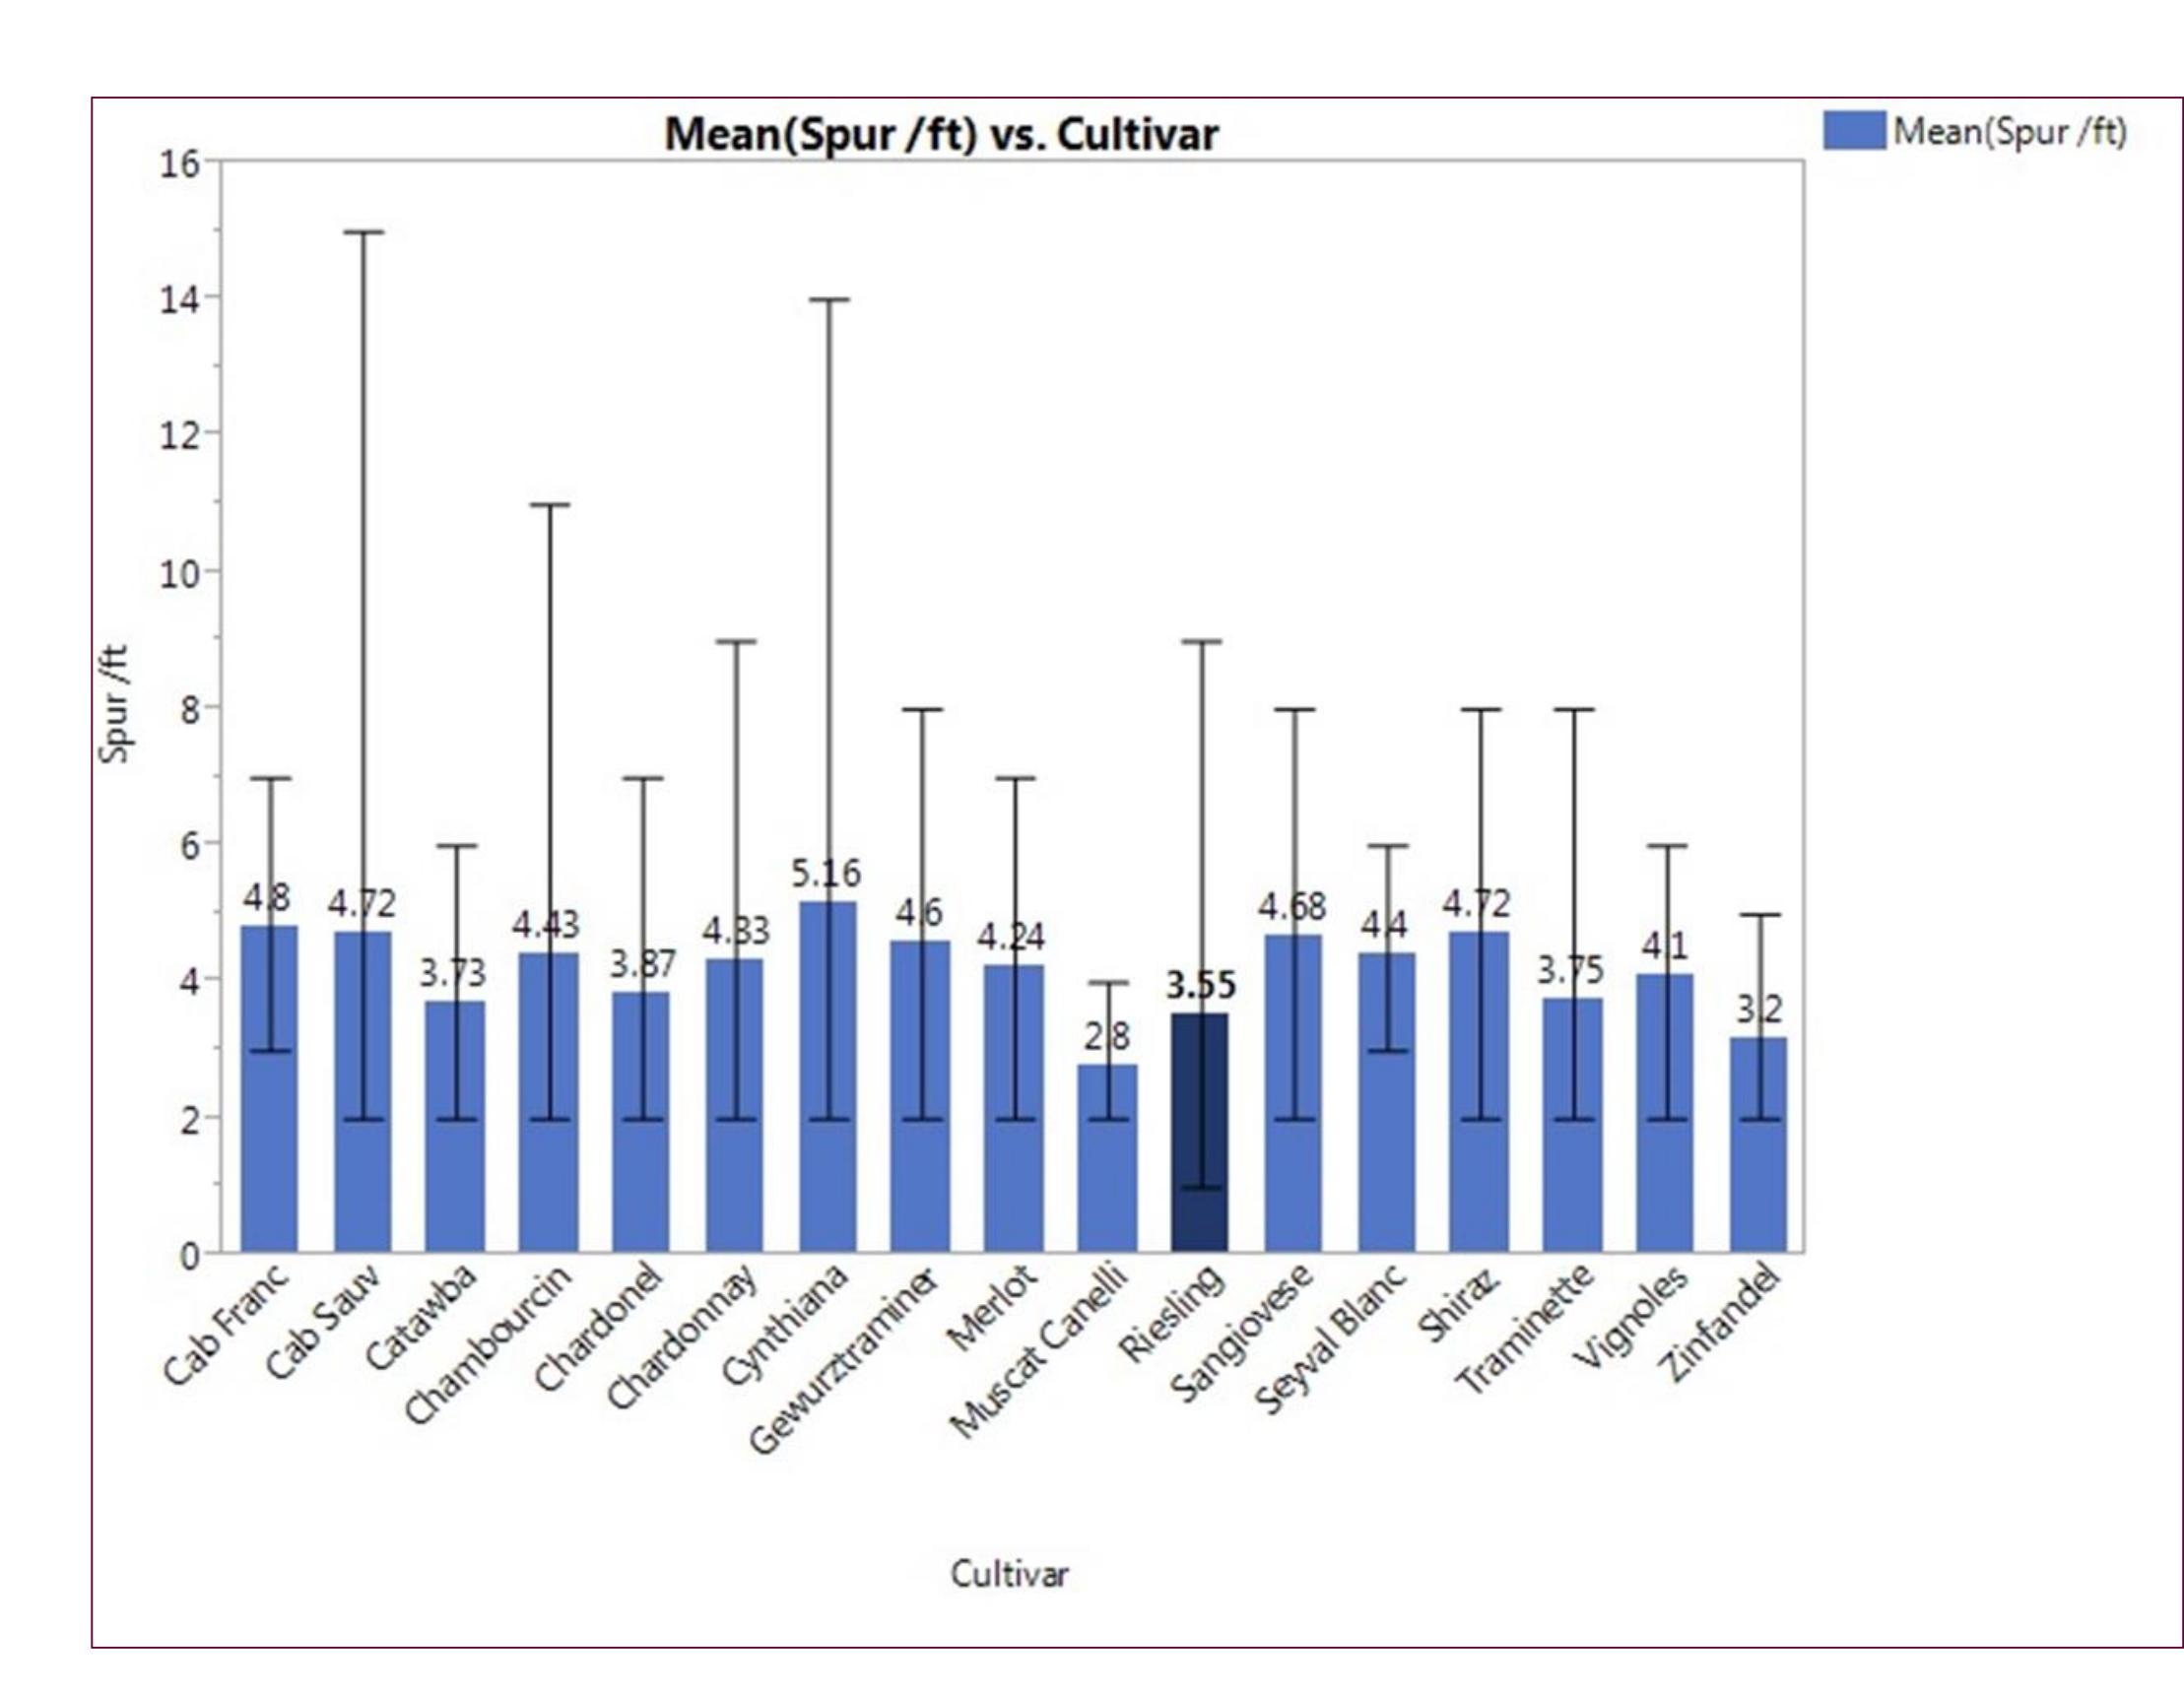
Fig. 5. Mean number of spurs per linear foot of row by cultivar. Only cultivars planted in at least two vineyards were analyzed.

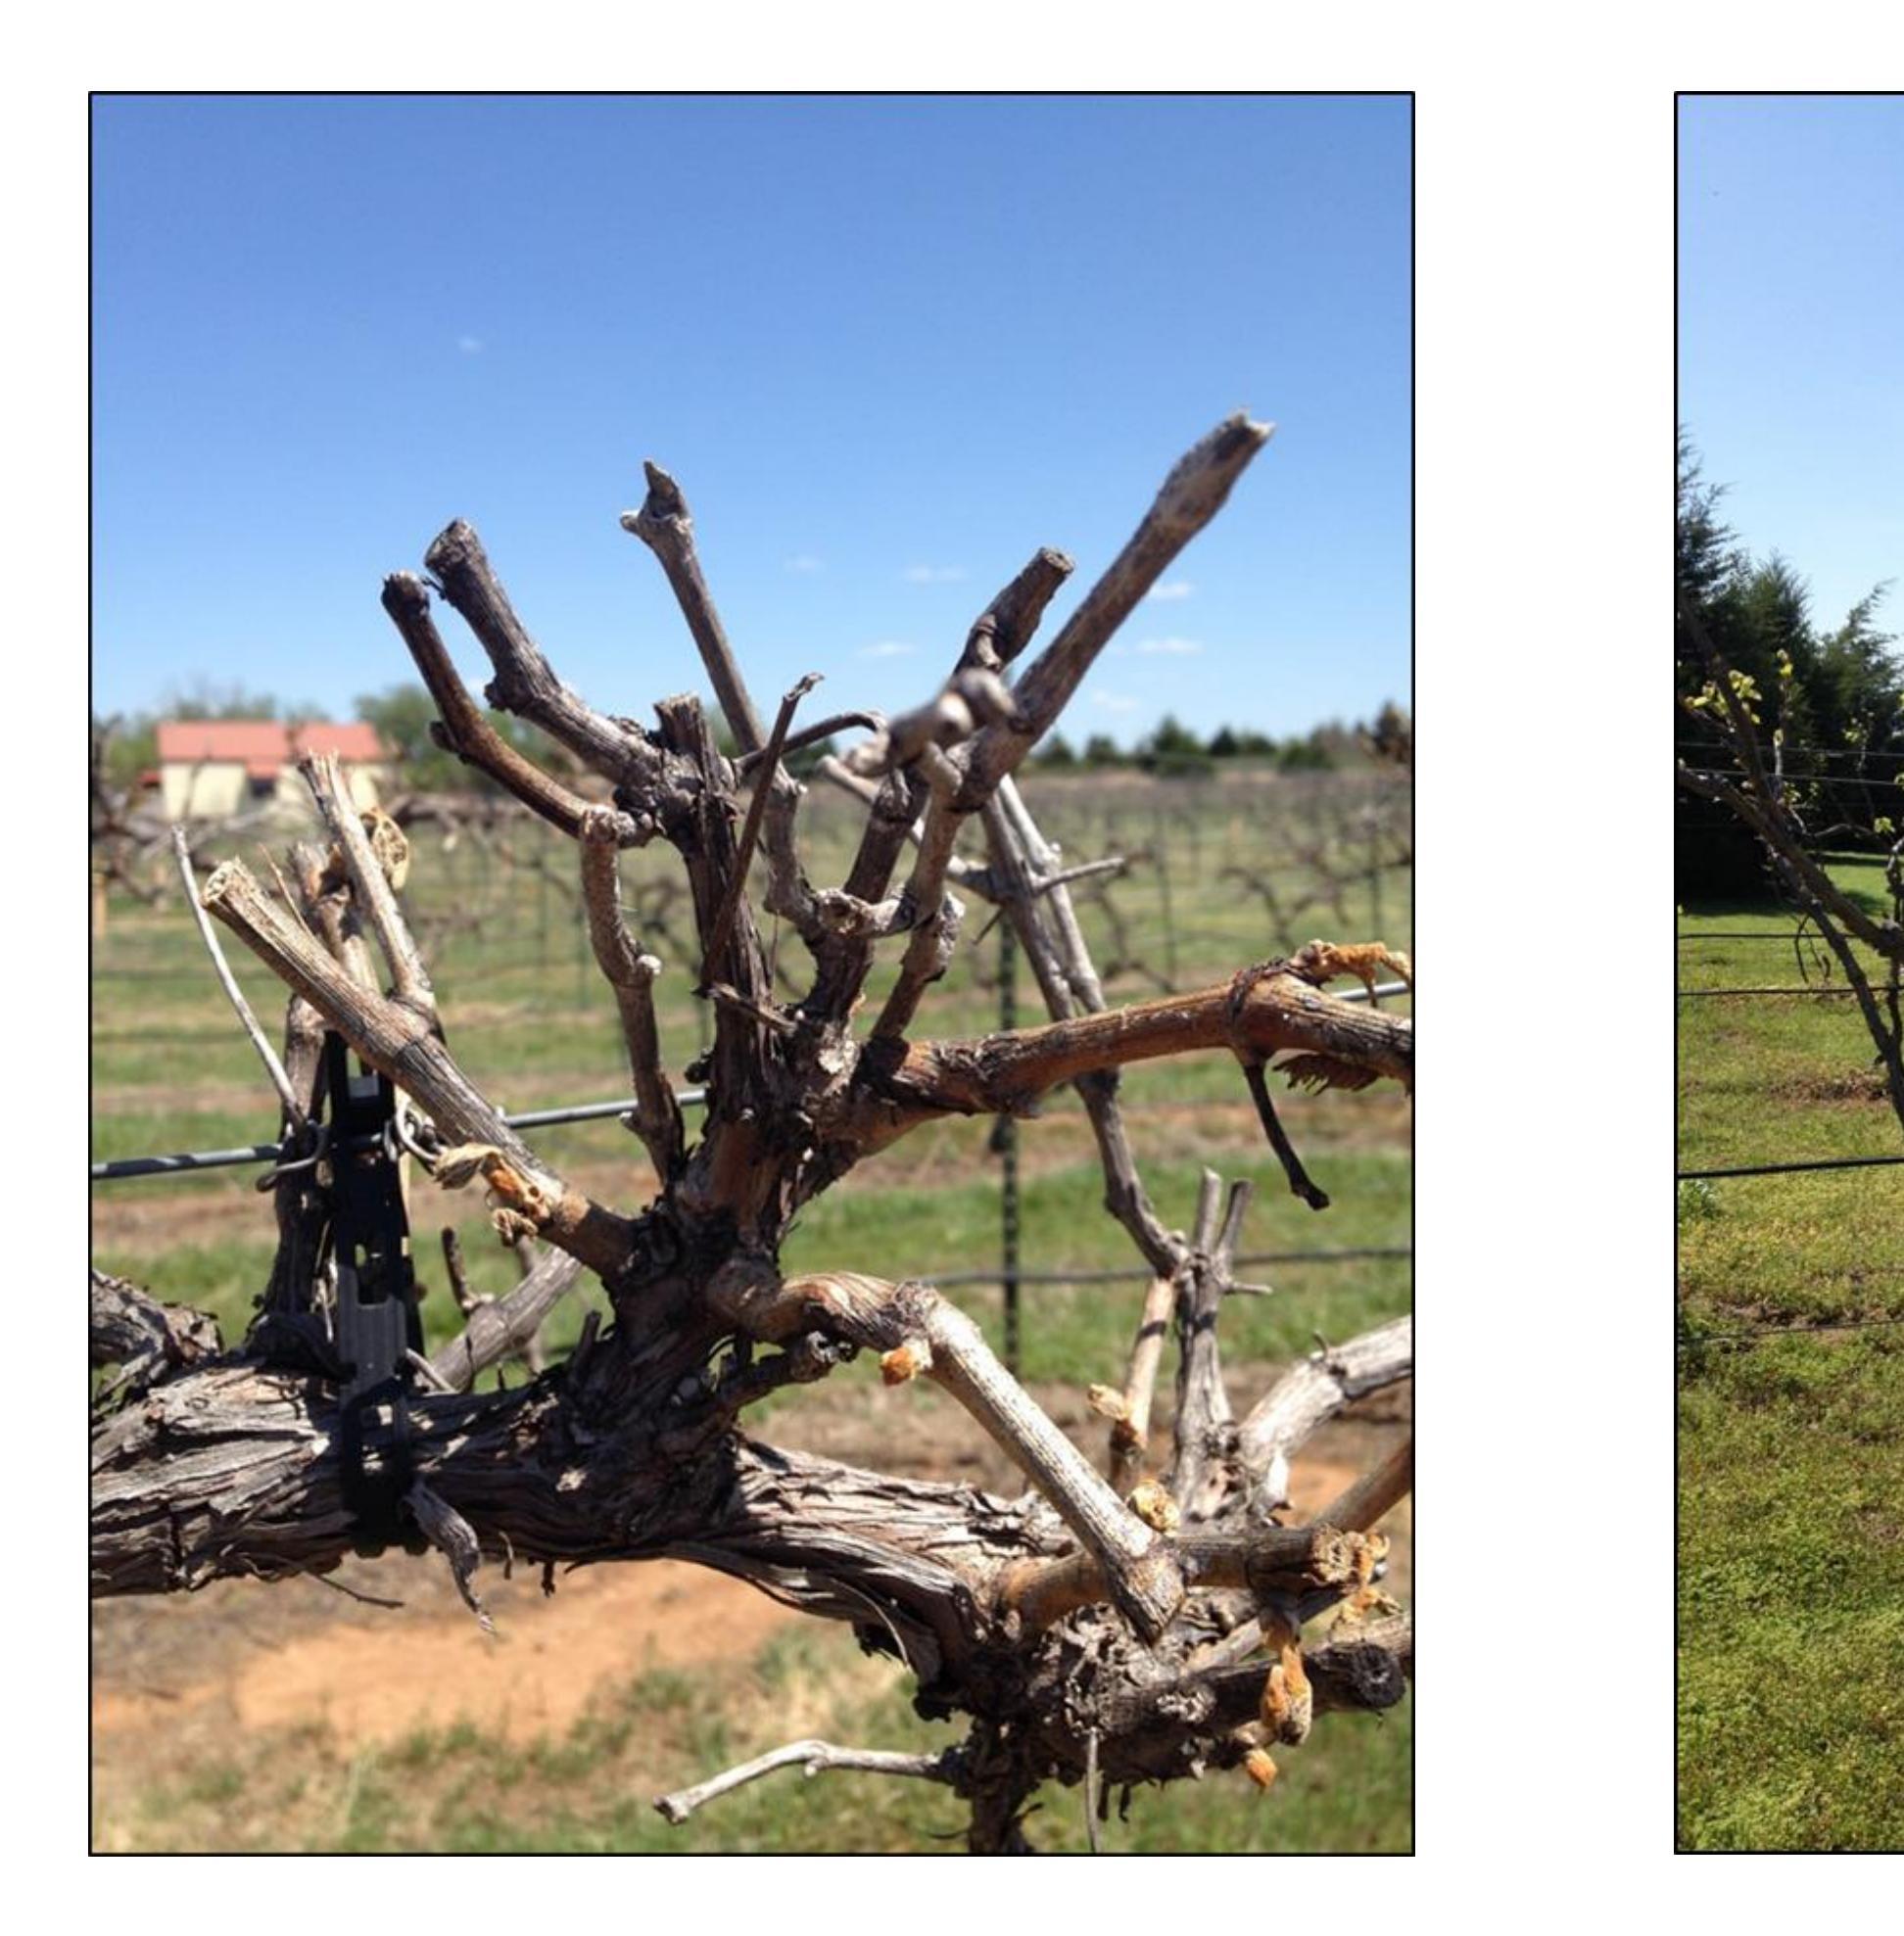
Fig. 6, 7. Examples of poor pruning practices observed in Oklahoma vineyards. Too many spurs (left) and lack of education (right) lead to poor pruning and fruit production and quality.

Overall there is a great deal to be concerned about regarding viticulture in Oklahoma (See Fig. 6,7). The primary concern is the long-term sustainability of vineyards throughout the state. Some of the more striking examples in 2014 are the lack of attentive management, poor pruning practices, lack of adequate pest control, poorly balanced vines and overall poor site selection. Many of these can be improved over time. Under current conditions, very few vineyards are well-run and are profitable.
